Technical Bulletin

BHA pin connection failure

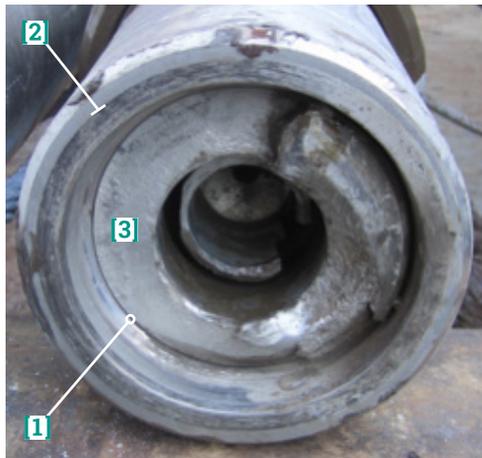
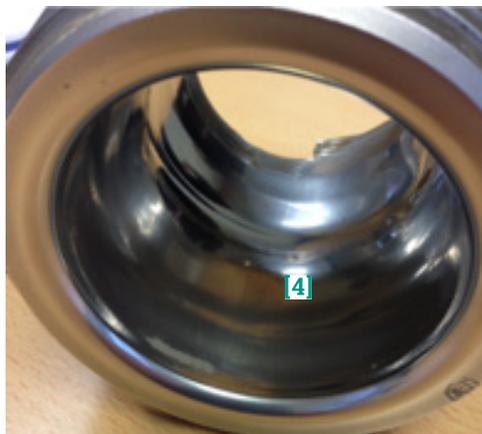
The BHA was seeing high torsional, bending and stick/slip loads (therefore significant fatigue) due to the amount of directional work being executed. The crossover sub did not have stress relief features.

The root cause of the failure was probably a high load that resulted in a 'fast fracture' (characterised by the large flat, grainy face on the left half of the failure [3]). The lack of a stress relief groove contributed to the failure and this can be demonstrated by the fact that the failure initiated at a stress raiser (thread root, see [1]). This stress raiser would not have existed had a 1" SRG been present. i.e. if the component had complied with the NS-1™ Standard.

Although they did not contribute to this failure, the miss-matched bevel diameters, evidenced by the size of the engaged seal area [2] do not comply with NS-2™ Standards and can also lead to failures.

The sub was manufactured to API Spec 7 in 2009. There is no evidence in the manufacturing certs that confirm the bore of the sub was surface treated (e.g. hammer peened) - This is an optional treatment in API Spec 7 but mandatory in NS-1™. Surface treatments which provide compressive residual stresses may provide additional resistance to transgranular stress corrosion cracking & corrosion pitting. There is also a significant amount of washing in the bore [4] from fluid flowing round the internal component (In place in photo above)

- > Make sure Contracts reference NS Standards for Manufacture (NS-1™) and Inspection (NS-2™).
- > Seriously consider utilising 3rd party QAQC verification prior to load-out. They would have highlighted the missing SRG, the mis-matched bevels, the washed bore and the incorrect spec of manufacture.
