Technical Bulletin

Backloading of drill pipe

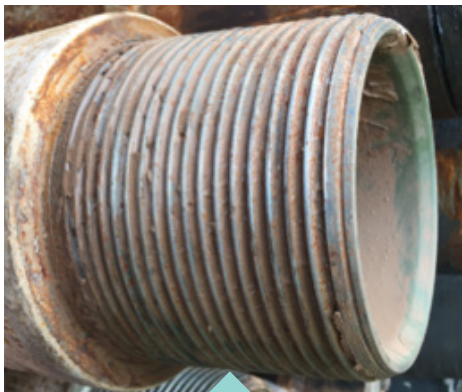
Rag removed from pin connection shows excessive corrosion on 'dry' seal face

It is apparent that none of the connections had been cleaned or doped during lay down. As the last well fluid the pipe saw was water based mud, the steel has already started to corrode. It is likely to result in many seal faces needing repaired.

When pipe is being returned onshore for maintenance or storage, it should be flushed out/washed down with water (fresh if possible) prior to being laid out. As a minimum, threads and seal faces should be thoroughly doped before proper plastic protectors are fitted.

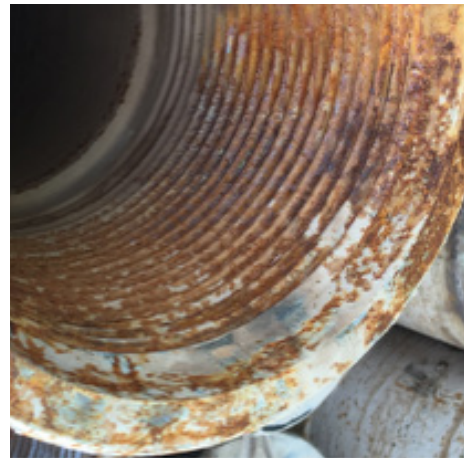
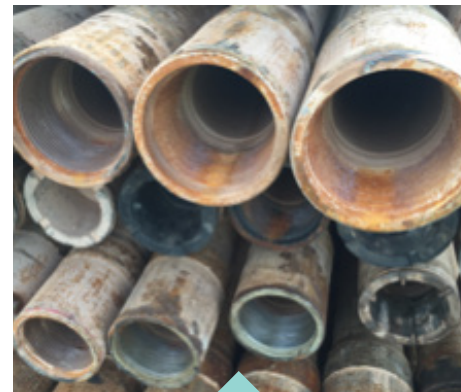
Pipe 'as returned'. Missing protectors and still partially coated with water based mud.

This drill string was backloaded from a rig working in the North Sea in 2015. The majority of the connections were shipped without proper thread protectors fitted.
