Technical Bulletin Identification of connection torque status

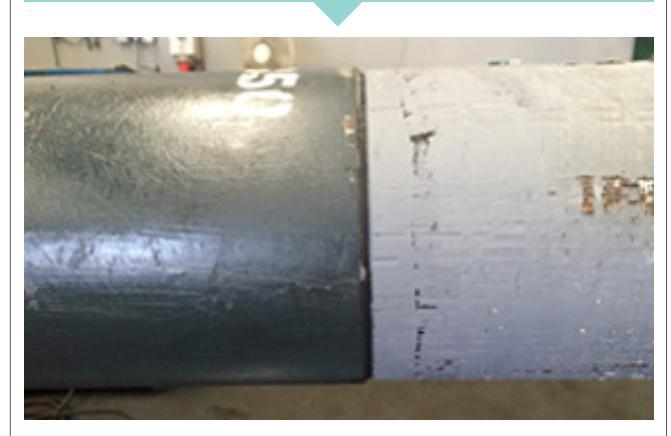
This connection is correctly torqued up but without any reference lines, it is difficult to physically confirm

Make-up torques should be carefully calculated for each pair of components and take into account the connection type, the thread compound used and the critical dimensions. A "controlled" procedure should be followed. It is recommended that the procedure advises that as soon as connections have been correctly torqued, they should have a clear line painted across both components. A good practice would also be to mark on the actual make-up torgue that had been applied so that any changes will be visible.

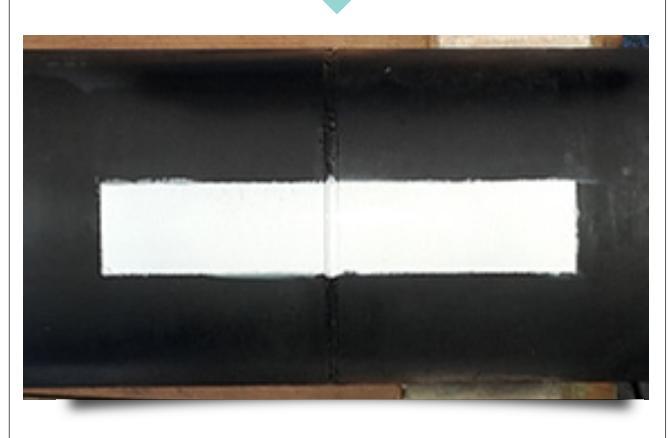
This connection is correctly torqued. If the lines are not aligned, then it indicates that something has changed and checks are required.
