Technical Bulletin

Evaluation of damage on connections

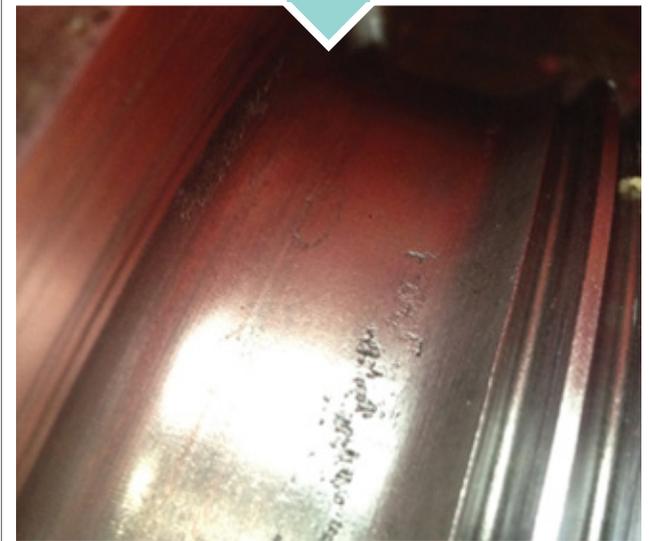
EXAMPLE: Corrosion pitting in a pin connection stress relief groove

The inspector felt that this pin connection was acceptable to use because “the pits are not 1/32” deep”. He had possibly not appreciated that the cumulative affect of this circumferential line of pits could be quite significant and lead to a crack developing.

Note: The stress relief groove is designed to remove stress raisers in this area of the pin connection which is susceptible to fatigue related failures in rotating applications.

Pit depth cannot be easily accurately measured and the effect of pitting in terms of fatigue is difficult for the inspector to assess. Where pitting depth is specified in NS-2™ it is provided as a guide to aid inspection - the inspector should become adept at visually estimating pitting depth, the surface area it covers and its location, it does not necessarily require physical measurement.
