Technical Bulletin

Rig Team Checks of Saver Subs

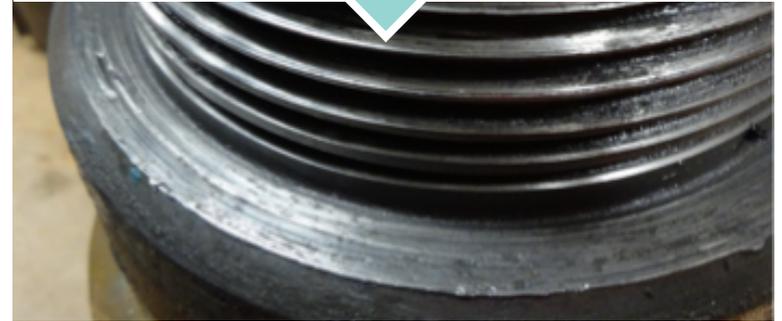
This picture shows galling damage to the threads but also excessive damage to the seal face

SEAL FACES Any galling or pitting of the seal surface that exceeds 1/32 inch (0.8 mm) in depth or occupy 25% of the seal width at any given location of the circumference is cause for concern.

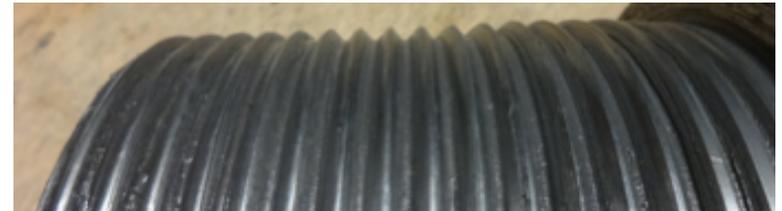
'Used' thread - Significantly worn down, with a sharp crest and significant material loss

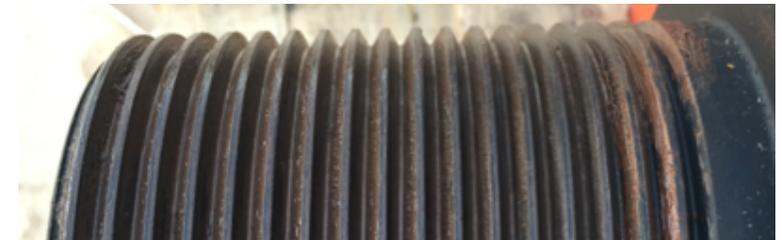
New thread - Notice the 'flat' on top of the thread crest and the thread height

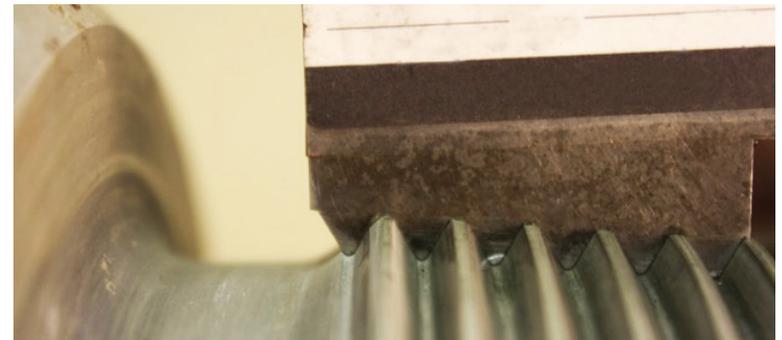
Hardened profile gauge in use

THREADS It is recommended that a thread profile gauge is kept on the rig floor purely for guidance. In a formal inspection, "the gauge shall conform to the thread profile so that no light is visible".
