Technical Bulletin

Backloading of drill pipe

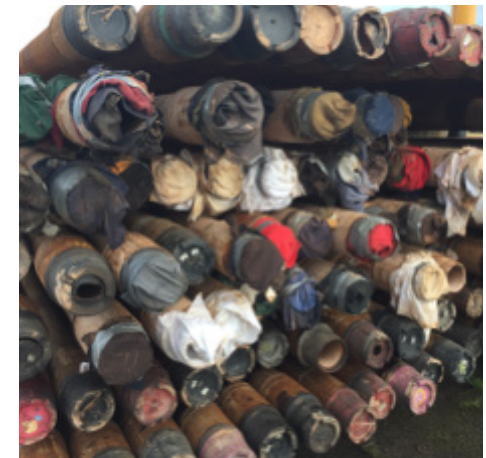
Pipe 'as returned'. Missing protectors and still partially coated with water based mud.

It is apparent that none of the connections had been cleaned or doped during lay down. As the last well fluid the pipe saw was water based mud, the steel has already started to corrode. It is likely to result in many seal faces needing repaired.

Note that seal faces which have already been refaced may now have to be fully recut, resulting in higher costs and lost time.

When pipe is being returned onshore for maintenance or storage, it should be flushed out/washed down with water (fresh if possible) prior to being laid out. As a minimum, threads and seal faces should be thoroughly doped before proper plastic protectors are fitted.
