Technical Bulletin

Marking of Verified Tools

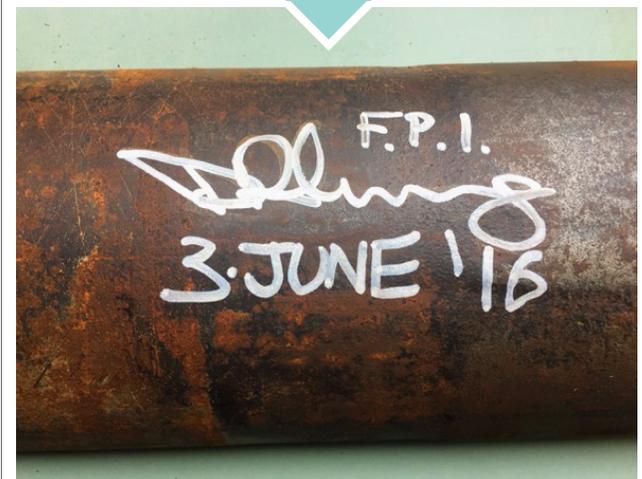
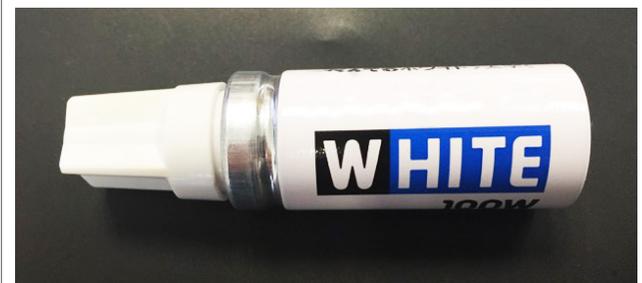
EXAMPLE: Marking of verified tools by Fearnley Procter

To show that Fearnley Procter Technicians have reviewed specific pieces of equipment, it is recommended that paint pens are used and the Technicians sign and date the component near the connection. (See example).

To avoid confusion with UK vs US format dates, the month should be written - 6th June 2016. Until familiarity is developed with rig crew recipients, it is recommended that the marking is photographed and included with release note emails.
